APPENDIX E SLOPE STABILITY ANALYSIS DONE BY USBR

IN-DELTA STORAGE PROGRAM ENGINEERING INVESTIGATIONS DRAFT REPORT

Plots from SlopeW Analysis done by US Bureau of Reclamation

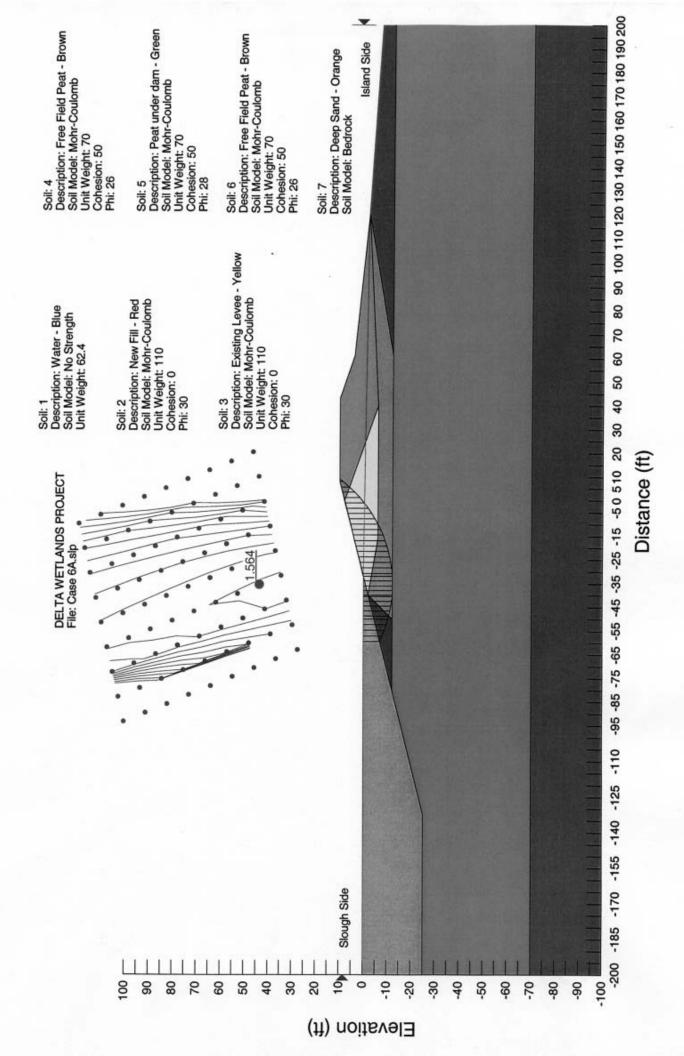
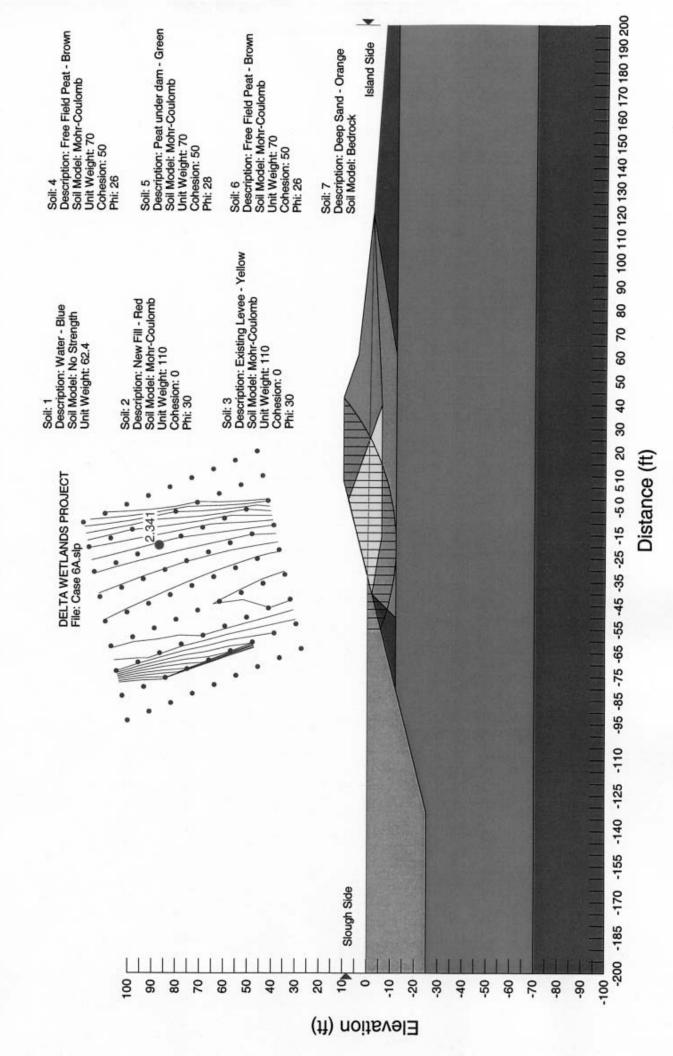
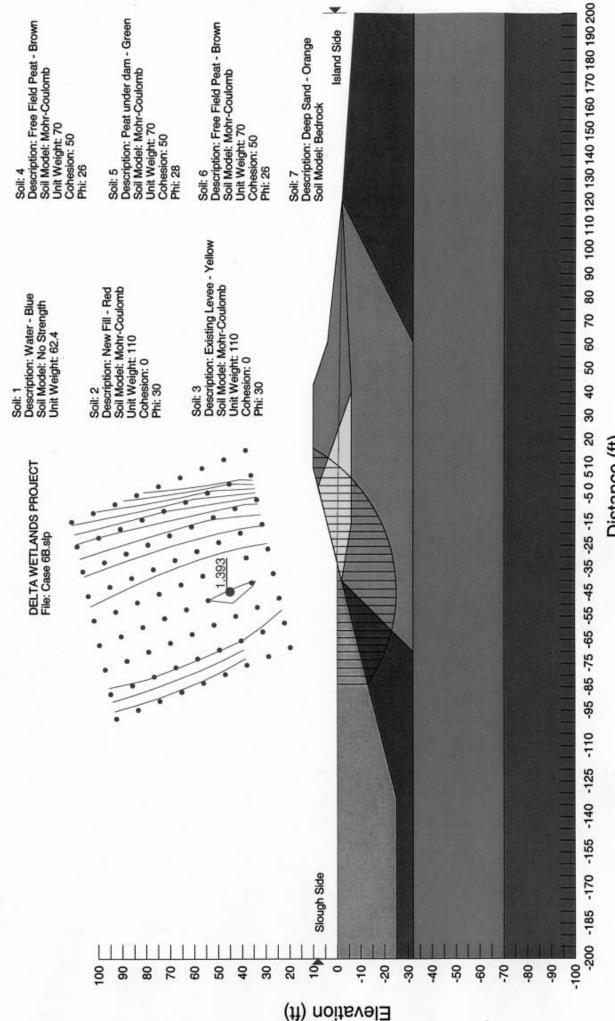
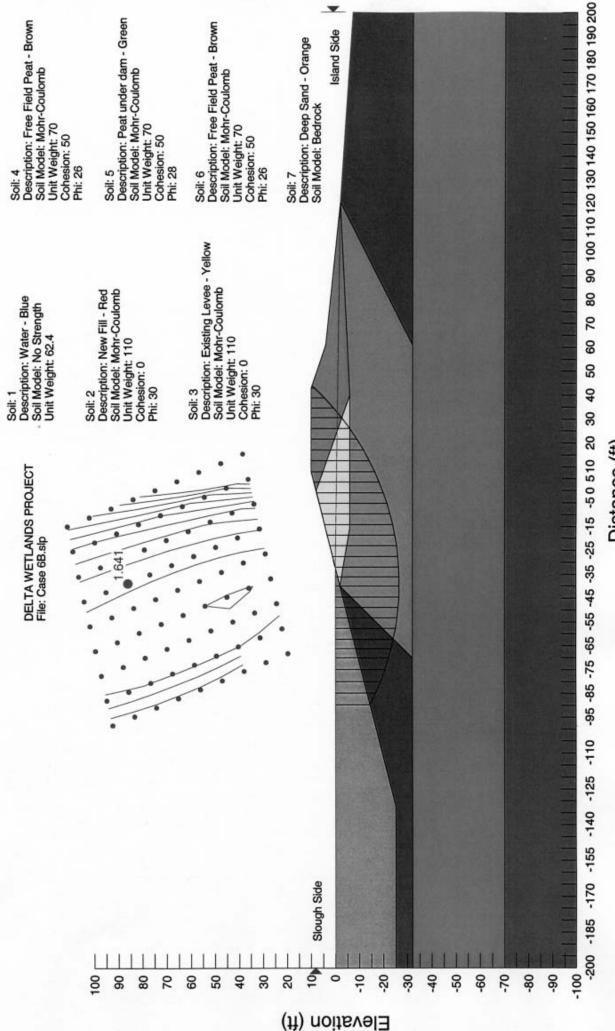
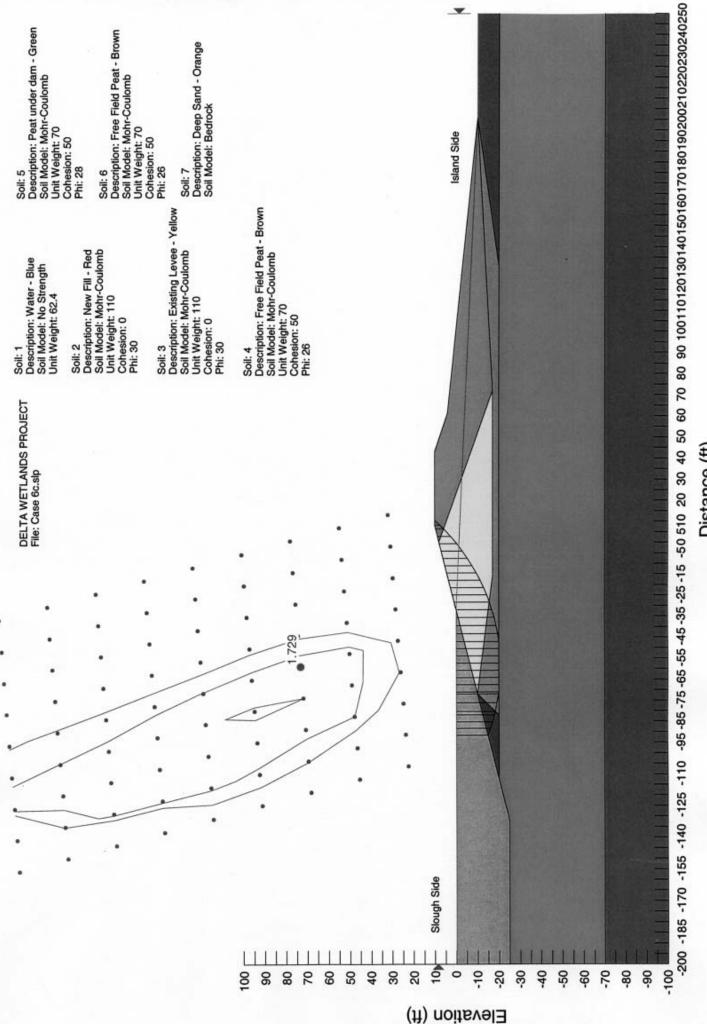
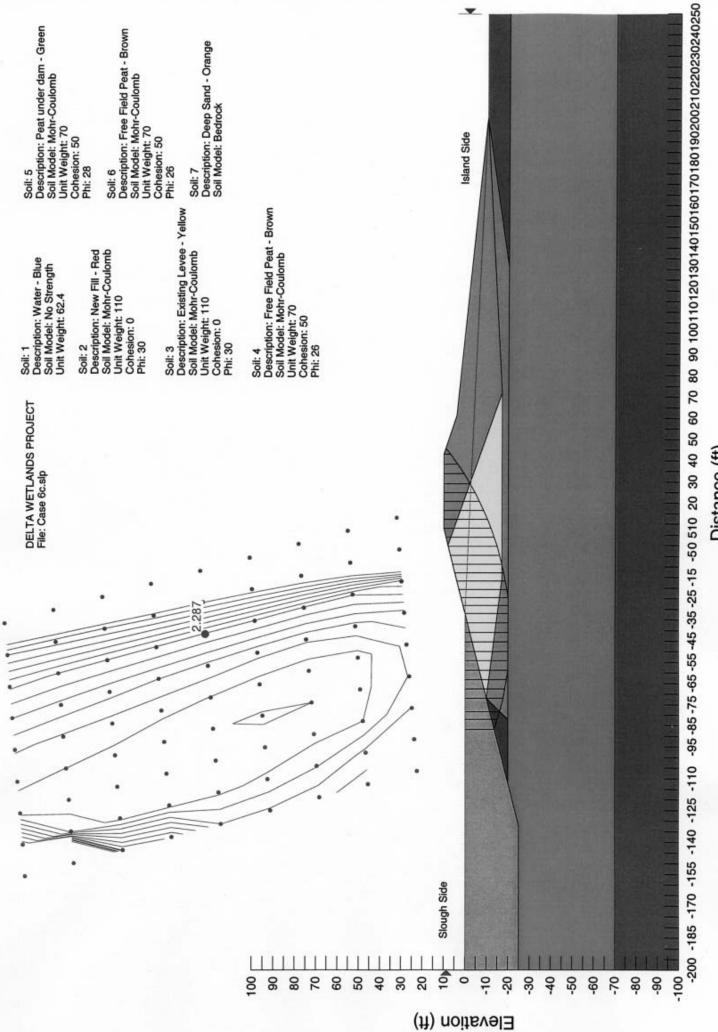
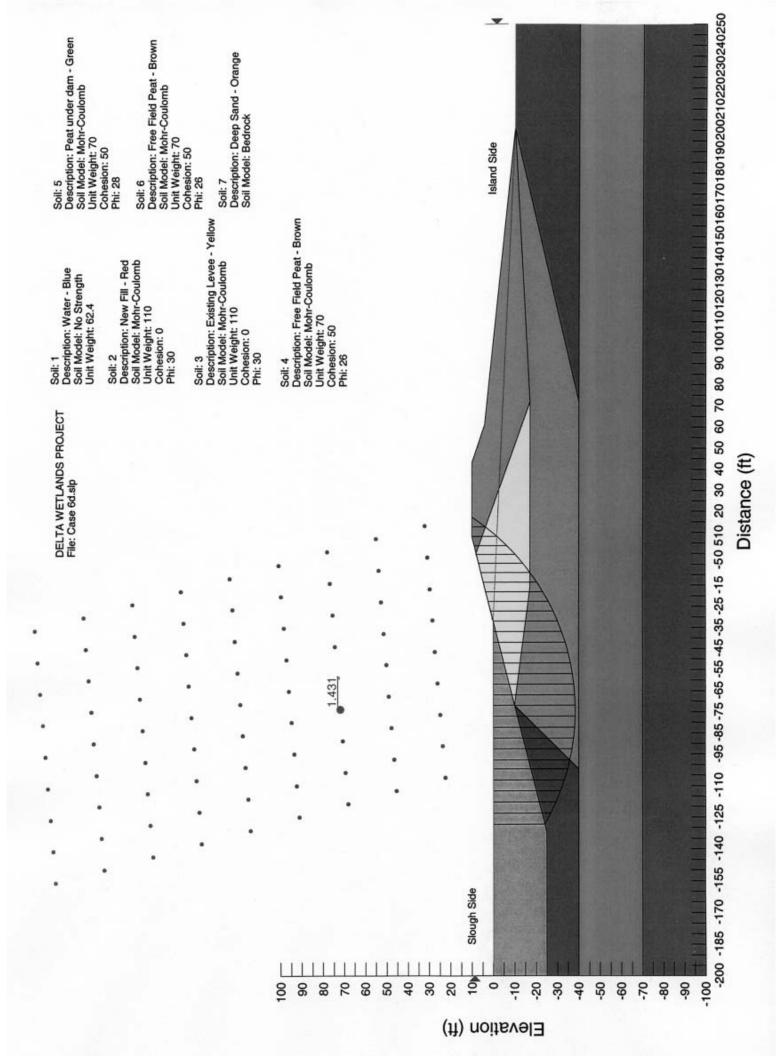
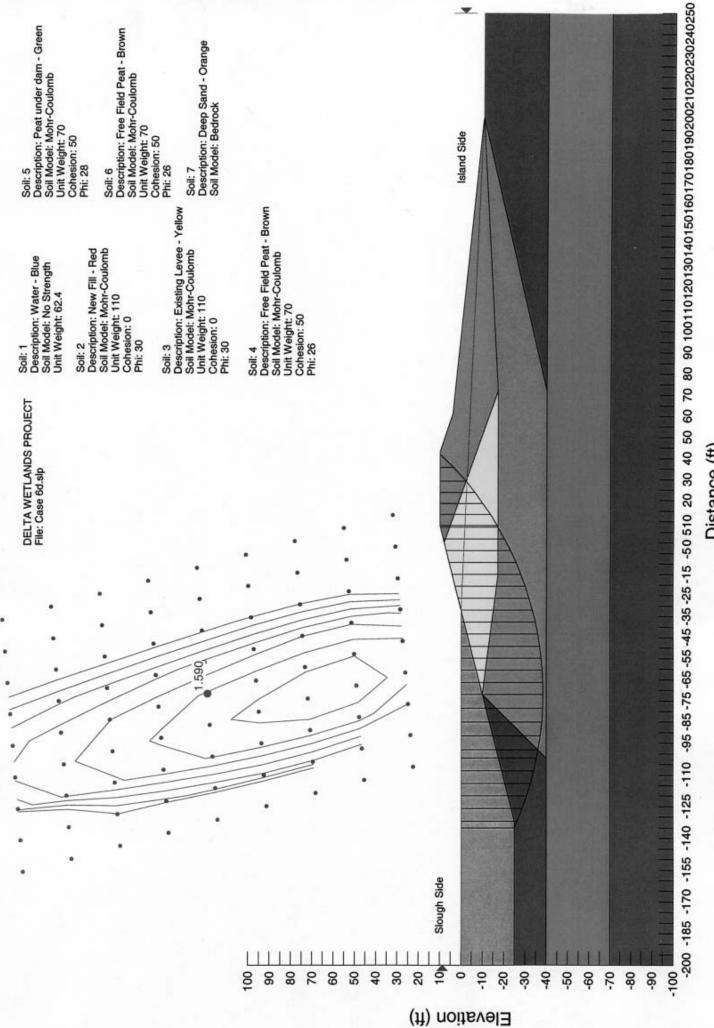
b. Steady-state Condition with Sliding Towards River/slough. - The analyses done for DW and confirmed in this analysis (as shown on Table x), indicate that a potential sliding failure into the river/sloughs exist for the steady-state condition. The factors of safety are below both the recommended dam and levee design criteria. This potential problem primarily exists where the channel is deep. The embankments with the existing slopes and a full reservoir have the potential to slide into the channels, which could cause unacceptable environmental damage, damage to floating structures, damage to adjacent levees, potential loss of life, and require expensive dredging to clean up. Loss of the reservoir may not occur because of the width of the embankments. The proposed modifications to the embankments by DW do not include modifying the river/slough side slopes. The costs for repairs and clean up of the slide mass would need to be accounted for in the overall cost of the DW proposed project.

Table x. DWR/BOR Factors of Safety for Steady-state Condition and Sliding Towards River/Slough

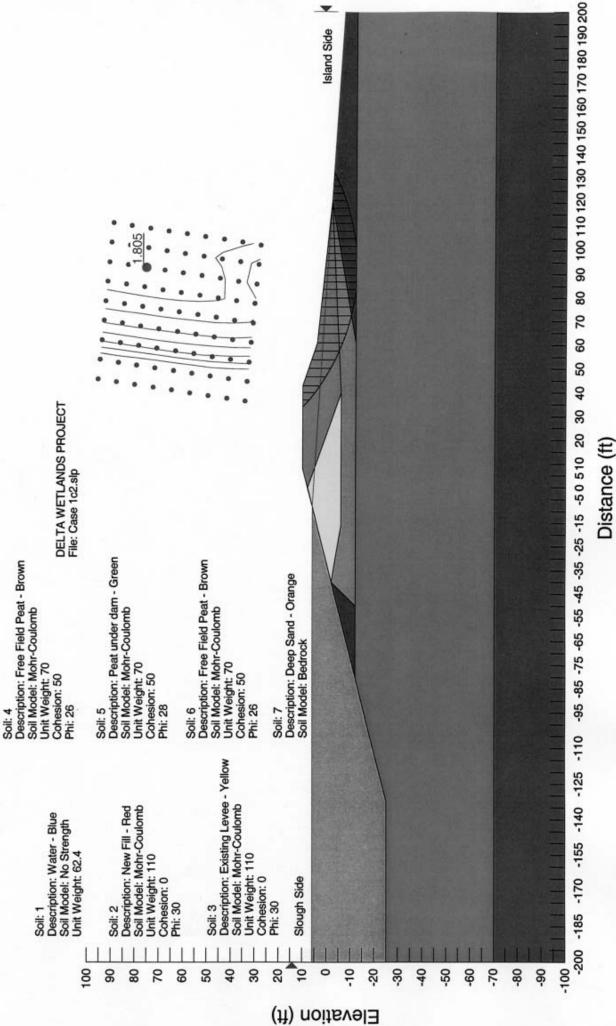
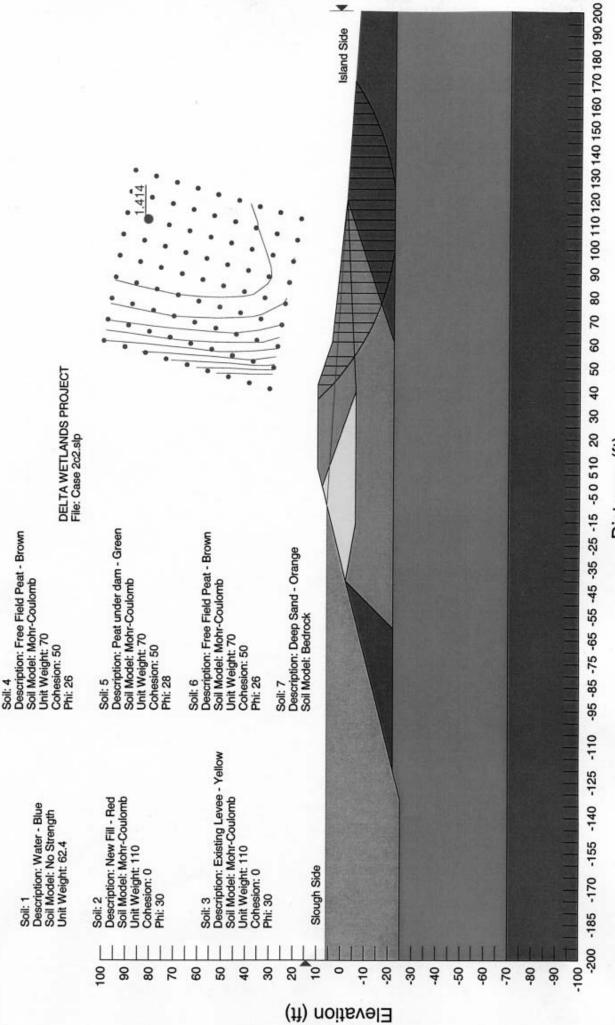
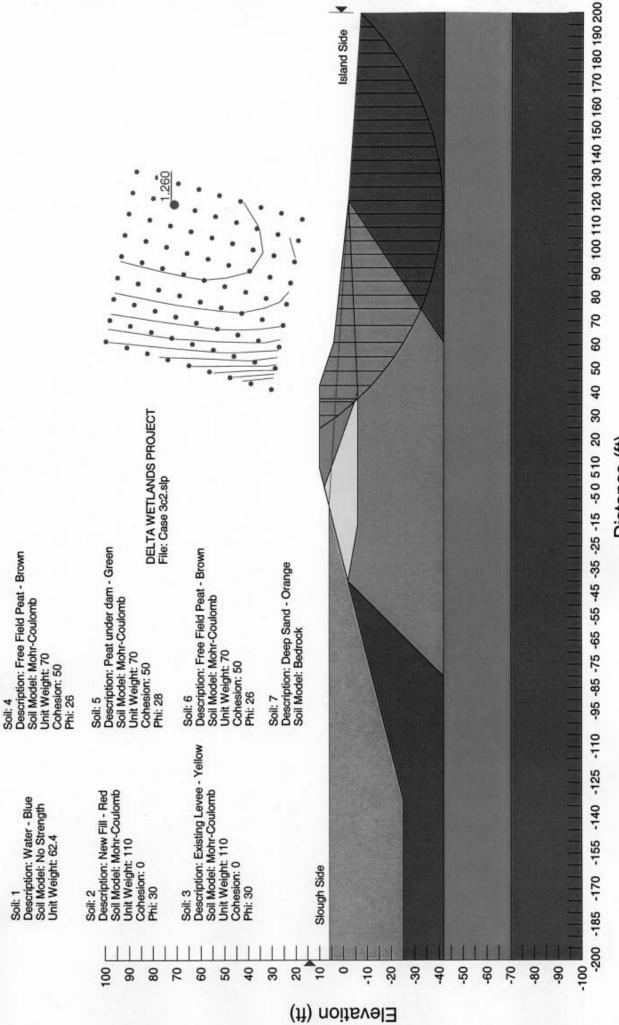
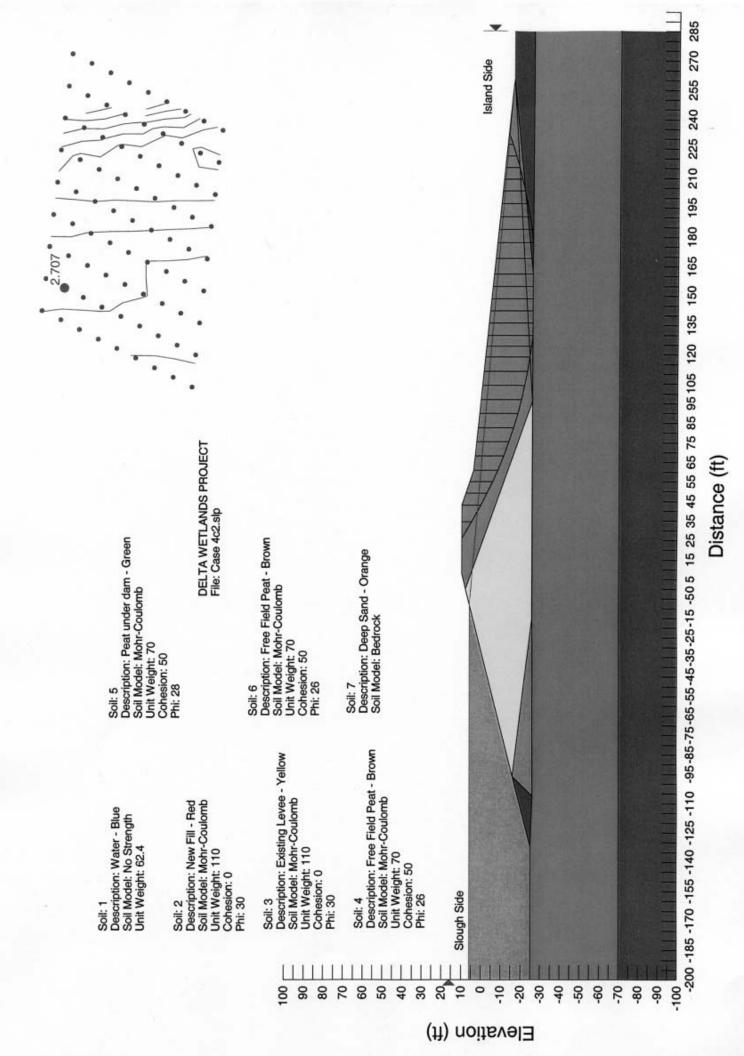
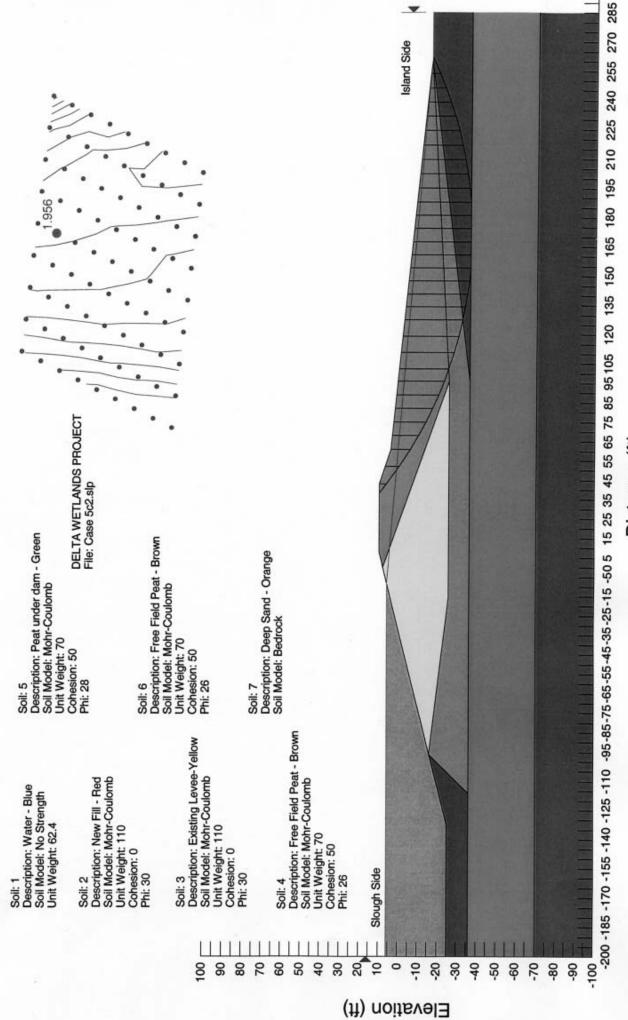
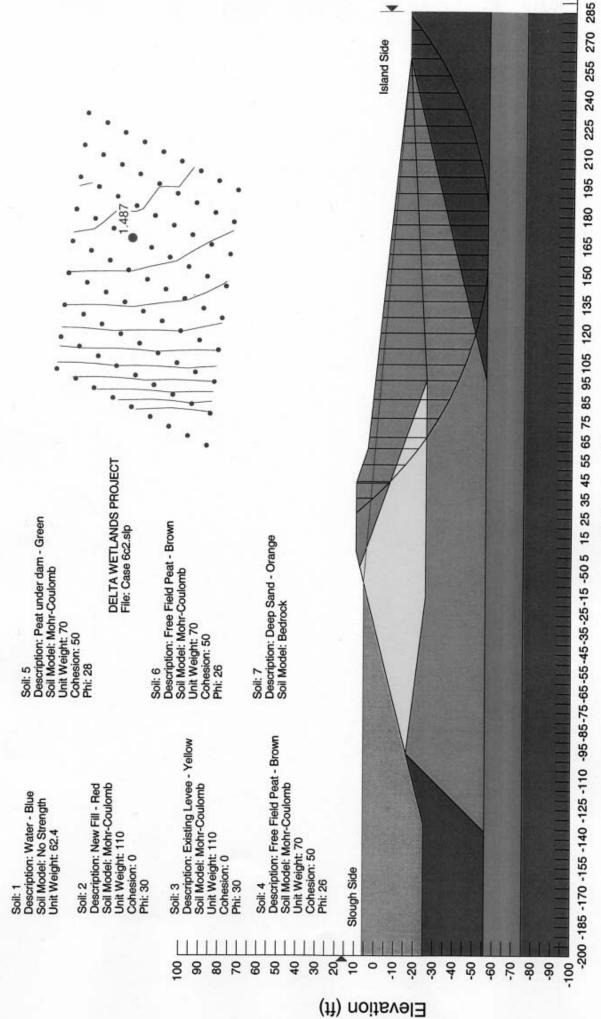
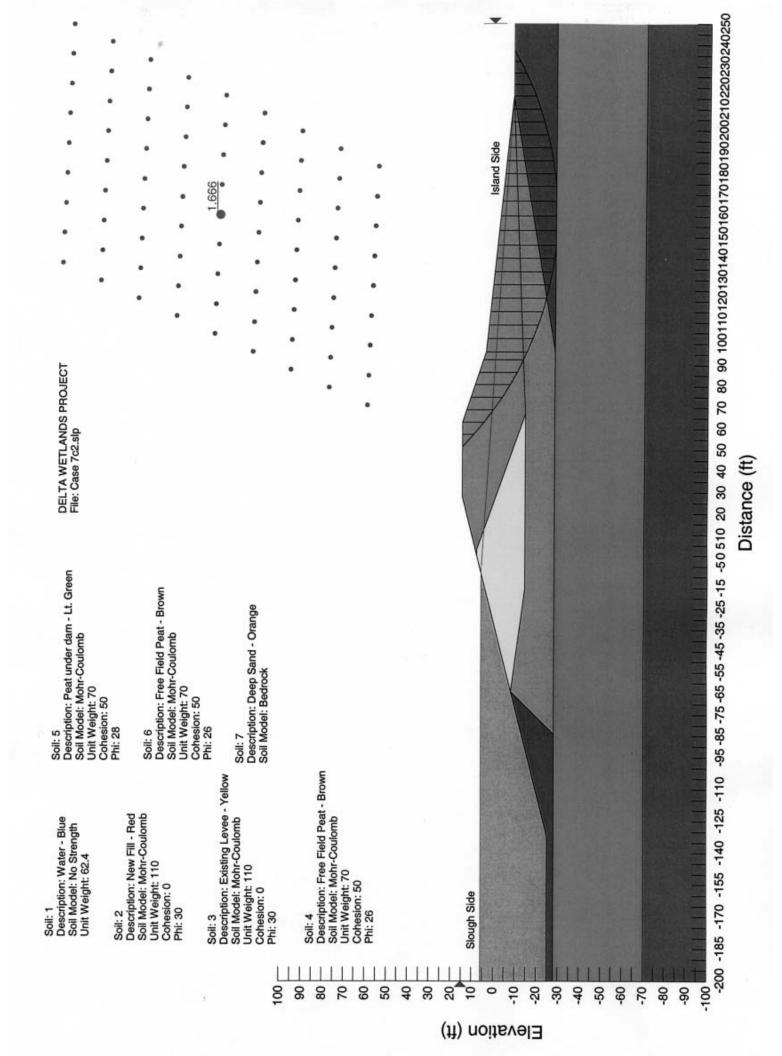
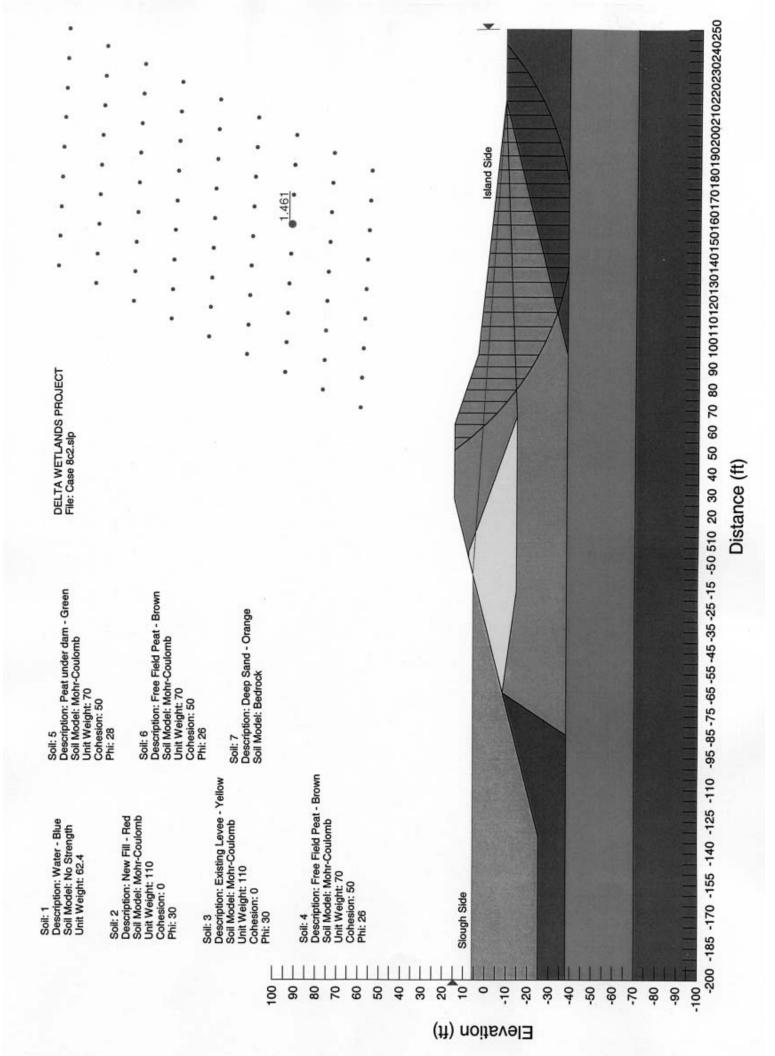
c. Steady-state Condition with Sliding Towards the Island Side. - The analyses performed to date for levees and for a storage reservoir indicate that slopes on the island side need to be 5:1 or flatter or be 3:1 with a buttressing berm. A continuous slope such as 5:1 general requires a greater volume of material so a steeper slope with a buttressing berm is generally more economical as illustrated on figure x. Actual slopes should be based upon economics (quantity of fill required), staged construction requirements, and achieving a factor of safety of approximately 1.5. Based on previous analyses and some additional analyses, as shown on Table x, DWR/BOR recommends that at this level of study a slope of 3:1 down to elevation 4 and a slope of 10:1 below that elevation should be used. More complete analysis should be done during final design to optimize slopes for different reaches of the embankments with different geometry and foundation conditions.

Table x. DWR/BOR Factors of Safety for Steady-state Condition and Sliding Towards Island

Assumes existing slope is approximately 4:1, new slope is 3:1 to elevation 4 and then 10:1, slough side slope is cut back to 4:1, and a new crest width of 35 feet, reservoir empty and river at elevation 6

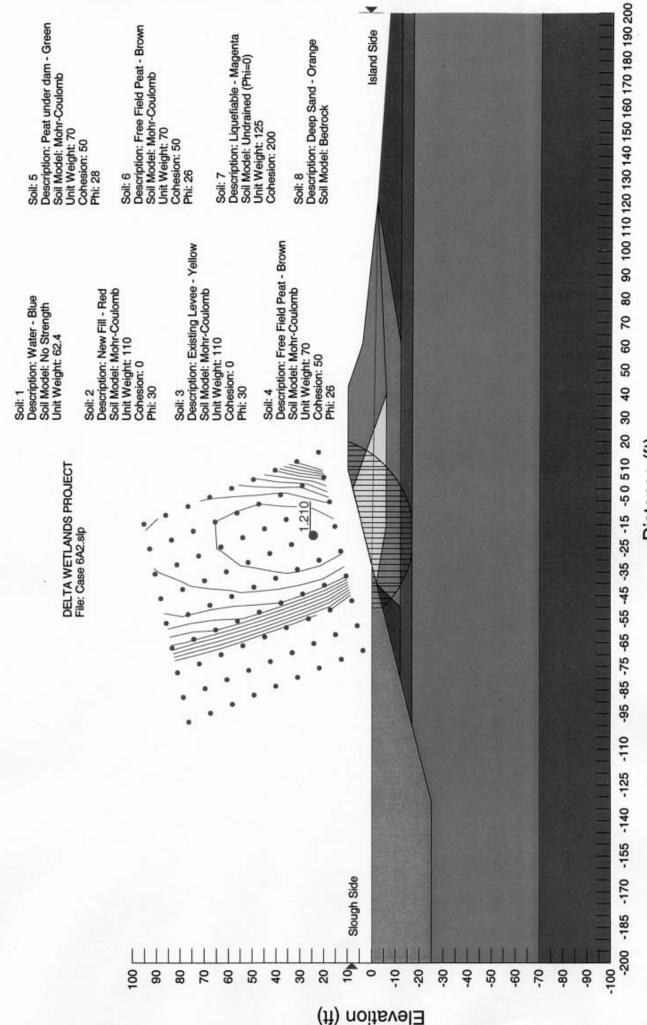
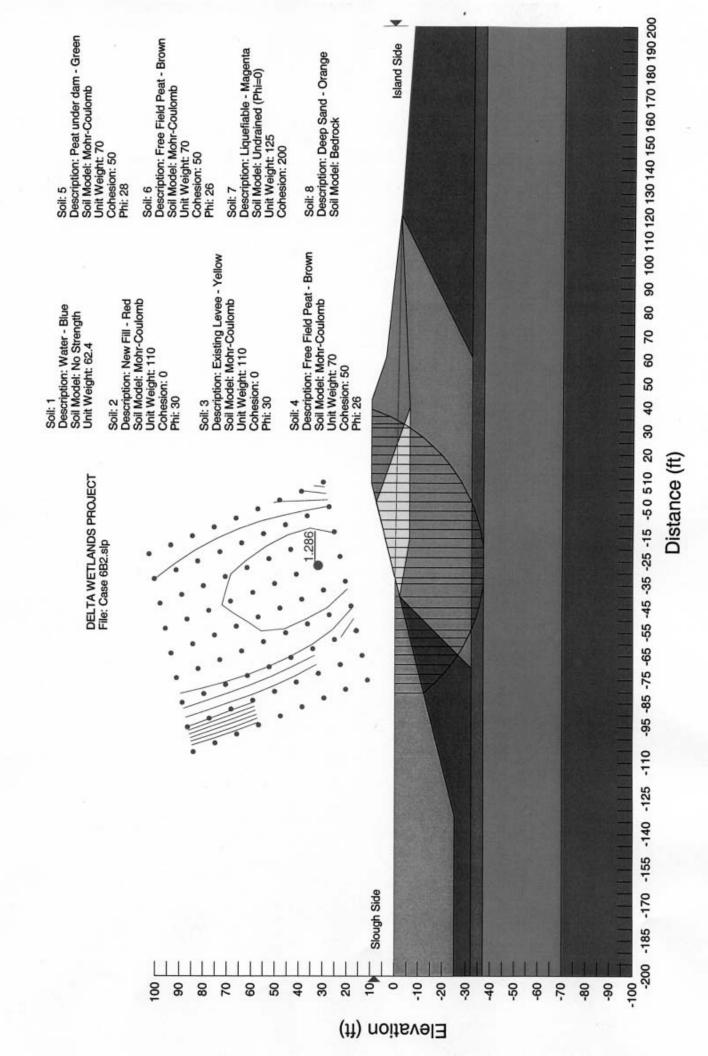
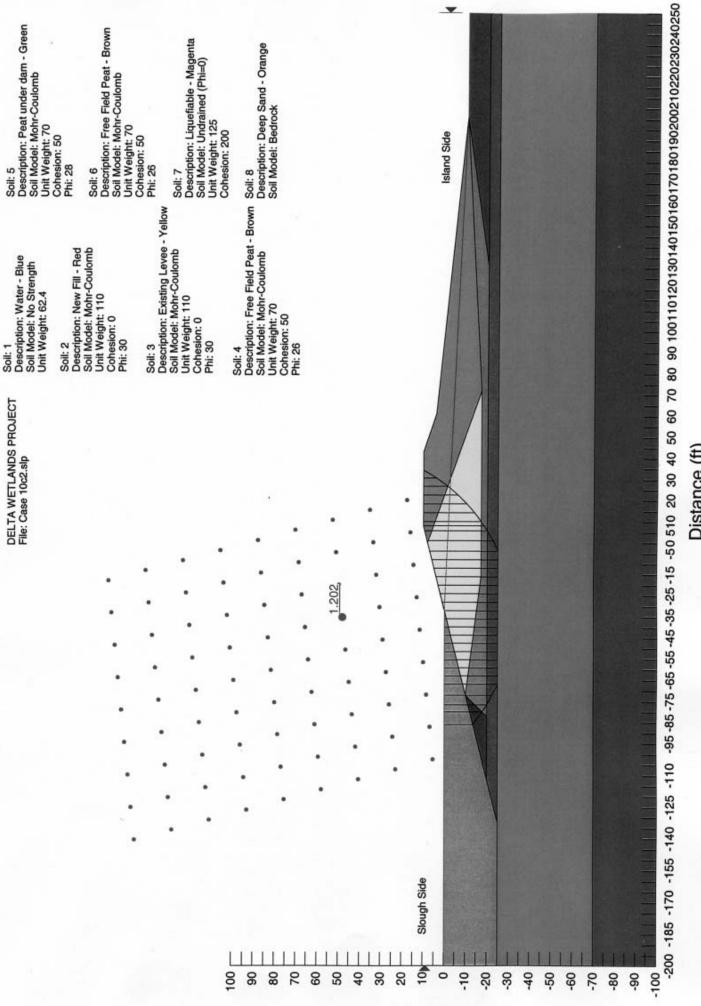
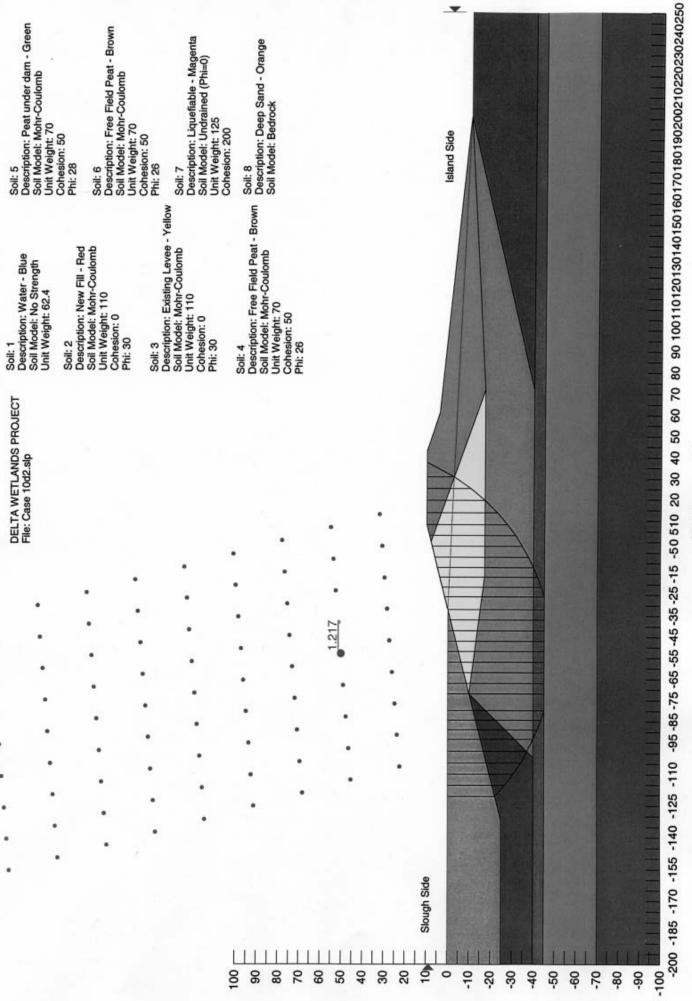
A post liquefaction analysis was performed on the same sections used for the steady-state analysis. Liquefied strengths of a small layer of material at the top of the sand layer was assumed to be 100, 200 and 400 psf. No other strength reductions were assumed. As shown in table x for sliding towards the river/slough if the liquefied strength is at least 200 psf a post-liquefaction sliding failure will not occur. As shown in table y for sliding towards the island if the liquefied strength is at least 200 psf a post-liquefaction sliding failure will probably not occur. During final design an in-depth analysis of the SPT data should be done to verify that the minimum liquefied strength is 200 psf. Future analyses should also evaluate the potential loss of strength in the peat material due to straining beyond the fiber bond strength.

Table x. DWR/BOR Factors of Safety for Post Liquefaction Condition and Sliding Towards River/Slough

^{*} Assumed 4:1 slope on the river/slough side, water in the slough to elevation 0 , no water in the reservoir, free field peat strength assumed to be c=50 psf and ϕ = 26, peat under embankment strength assumed to be c=50 psf and ϕ = 28

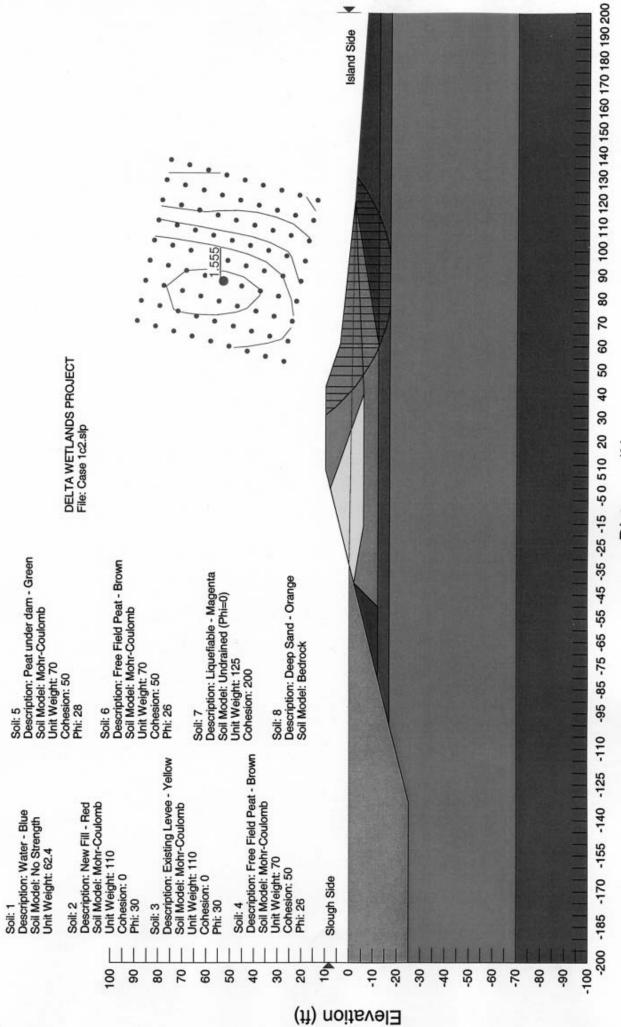
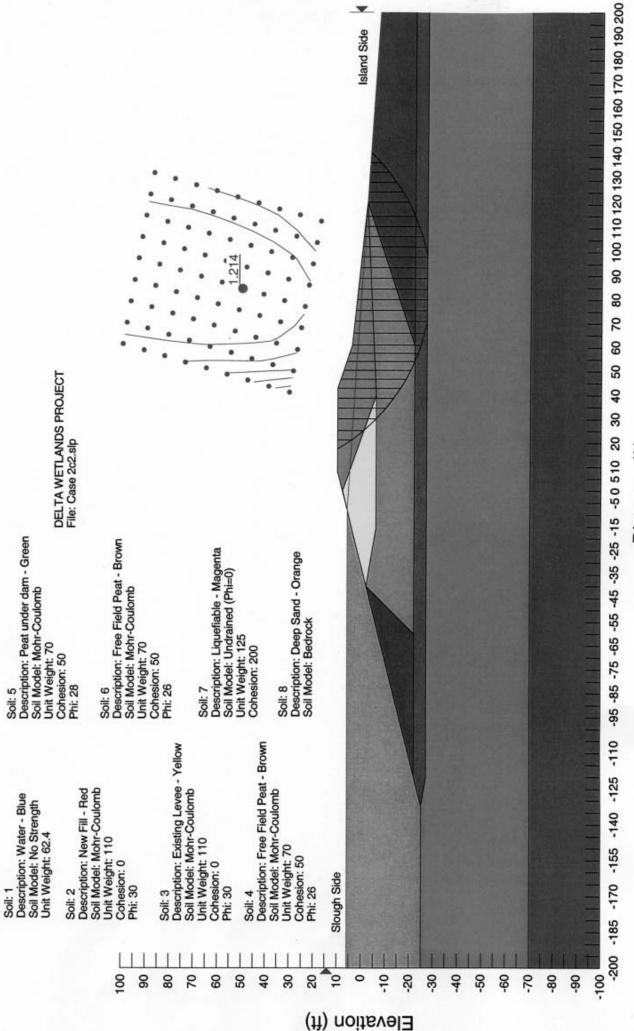
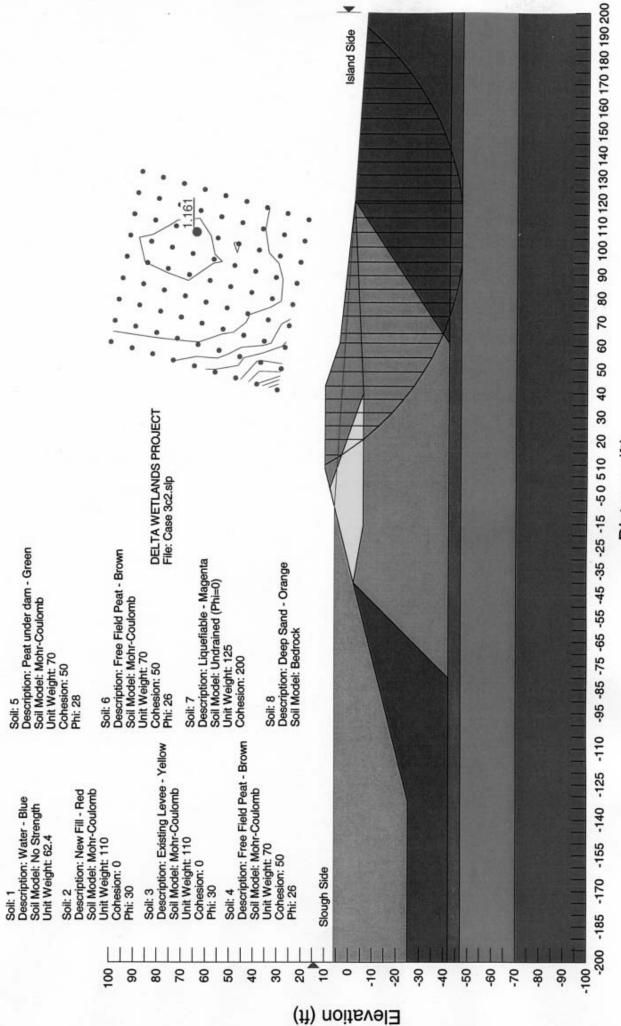
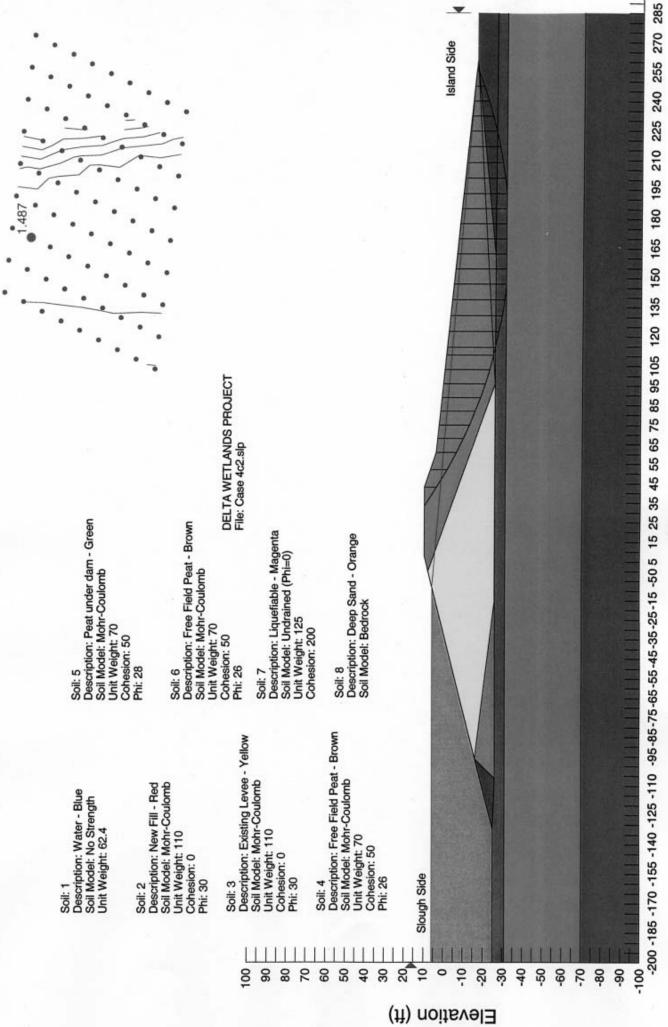
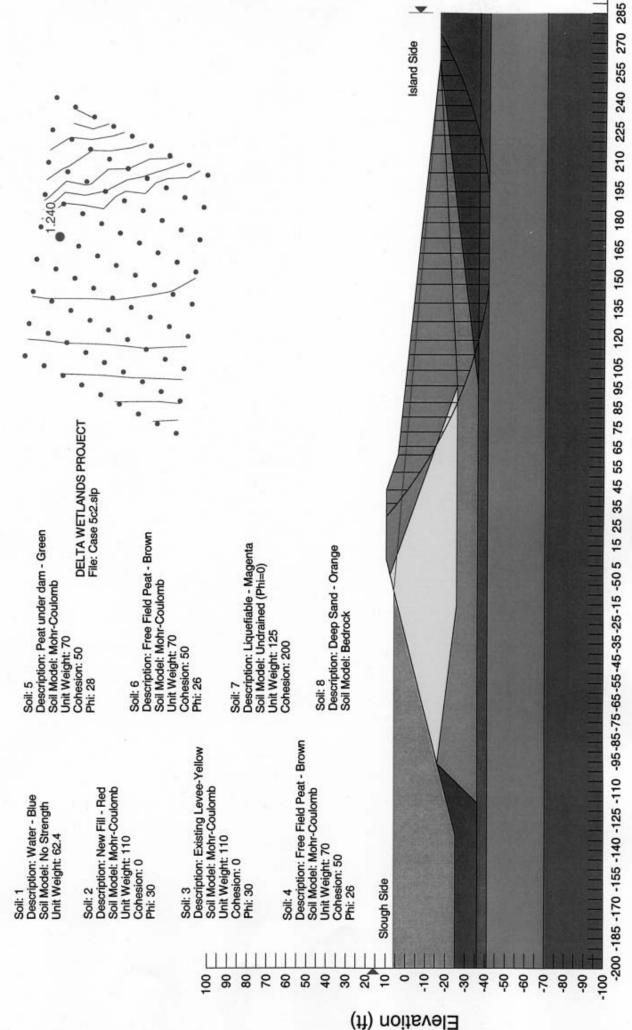
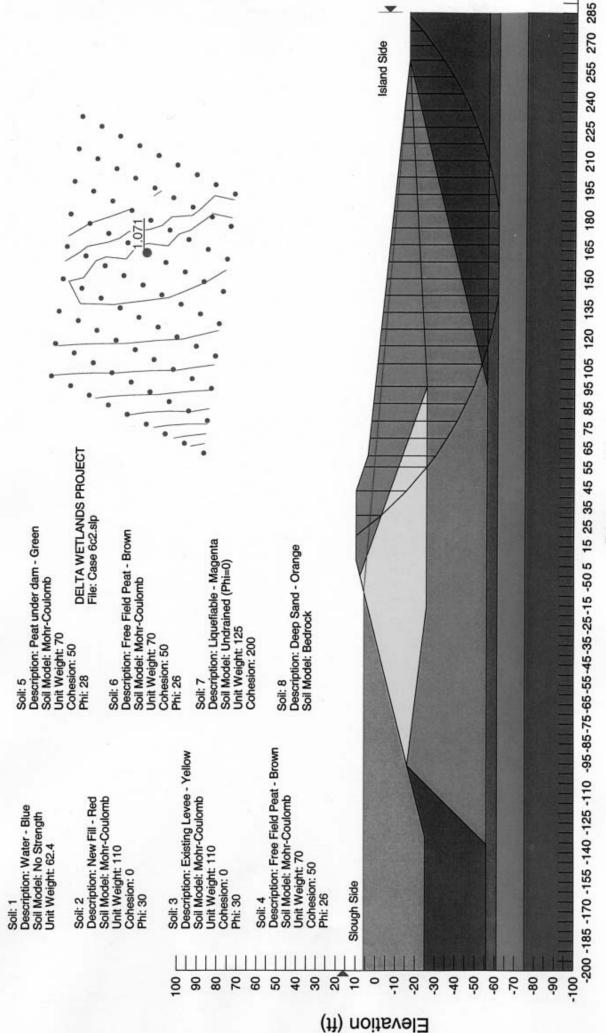
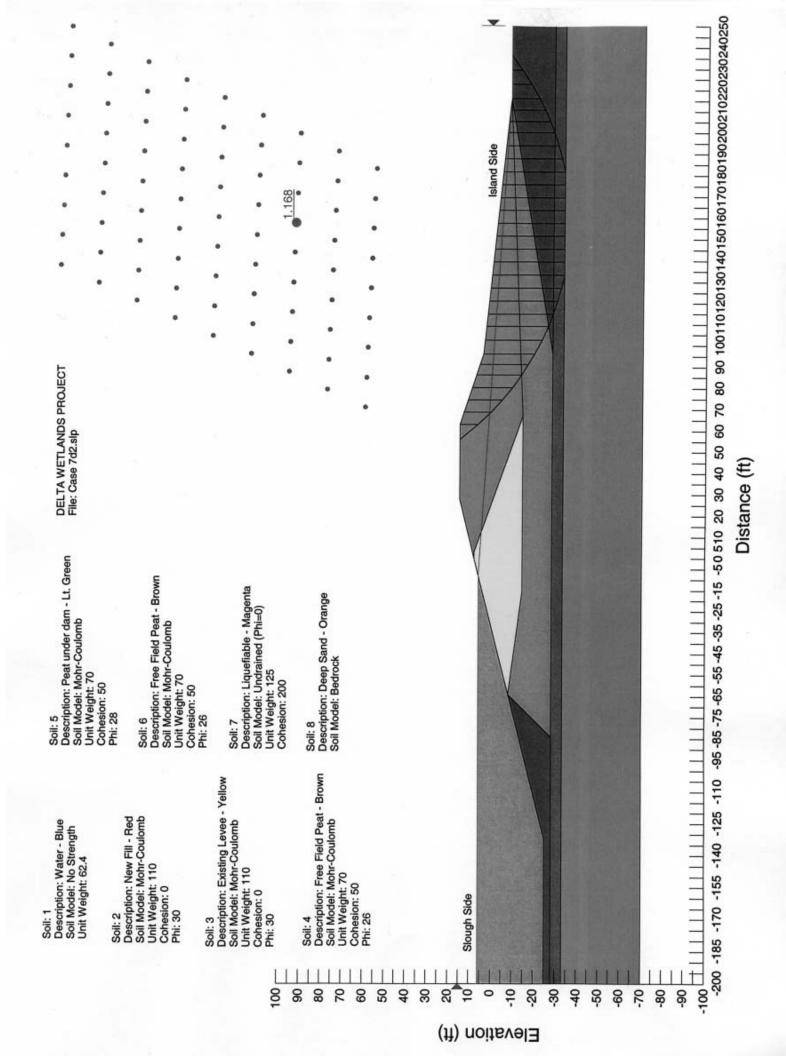
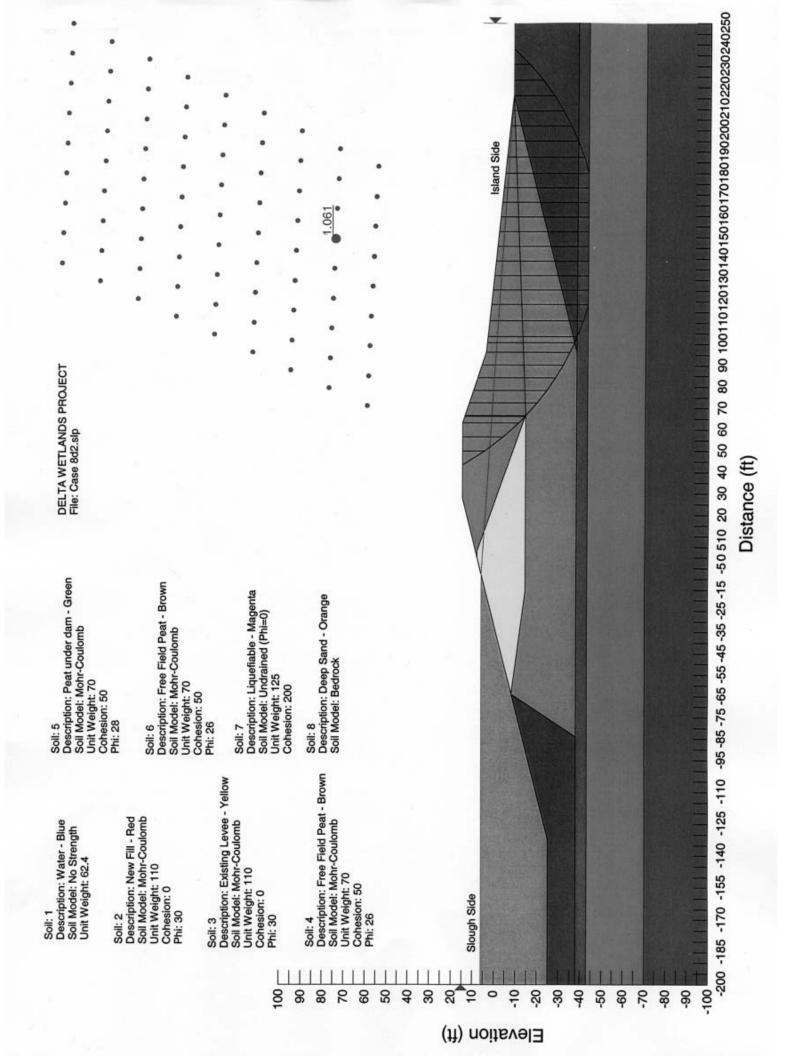
Table y. DWR/BOR Factors of Safety for Post Liquefaction Condition and Sliding Towards Island

Assumes existing slope is approximately 4:1, new slope is 3:1 to elevation 4 and then 10:1, slough side slope is cut back to 4:1, and a new crest width of 35 feet, reservoir empty and river at elevation 6
